EPA PROJECT  
ECOLOGY AND ENVIRONMENT, INC.

MEMORANDUM:      REGION V

SUBJECT: Site Inspection of Danville Plating Company (5-8211-5)

DATE:   November 24, 1982

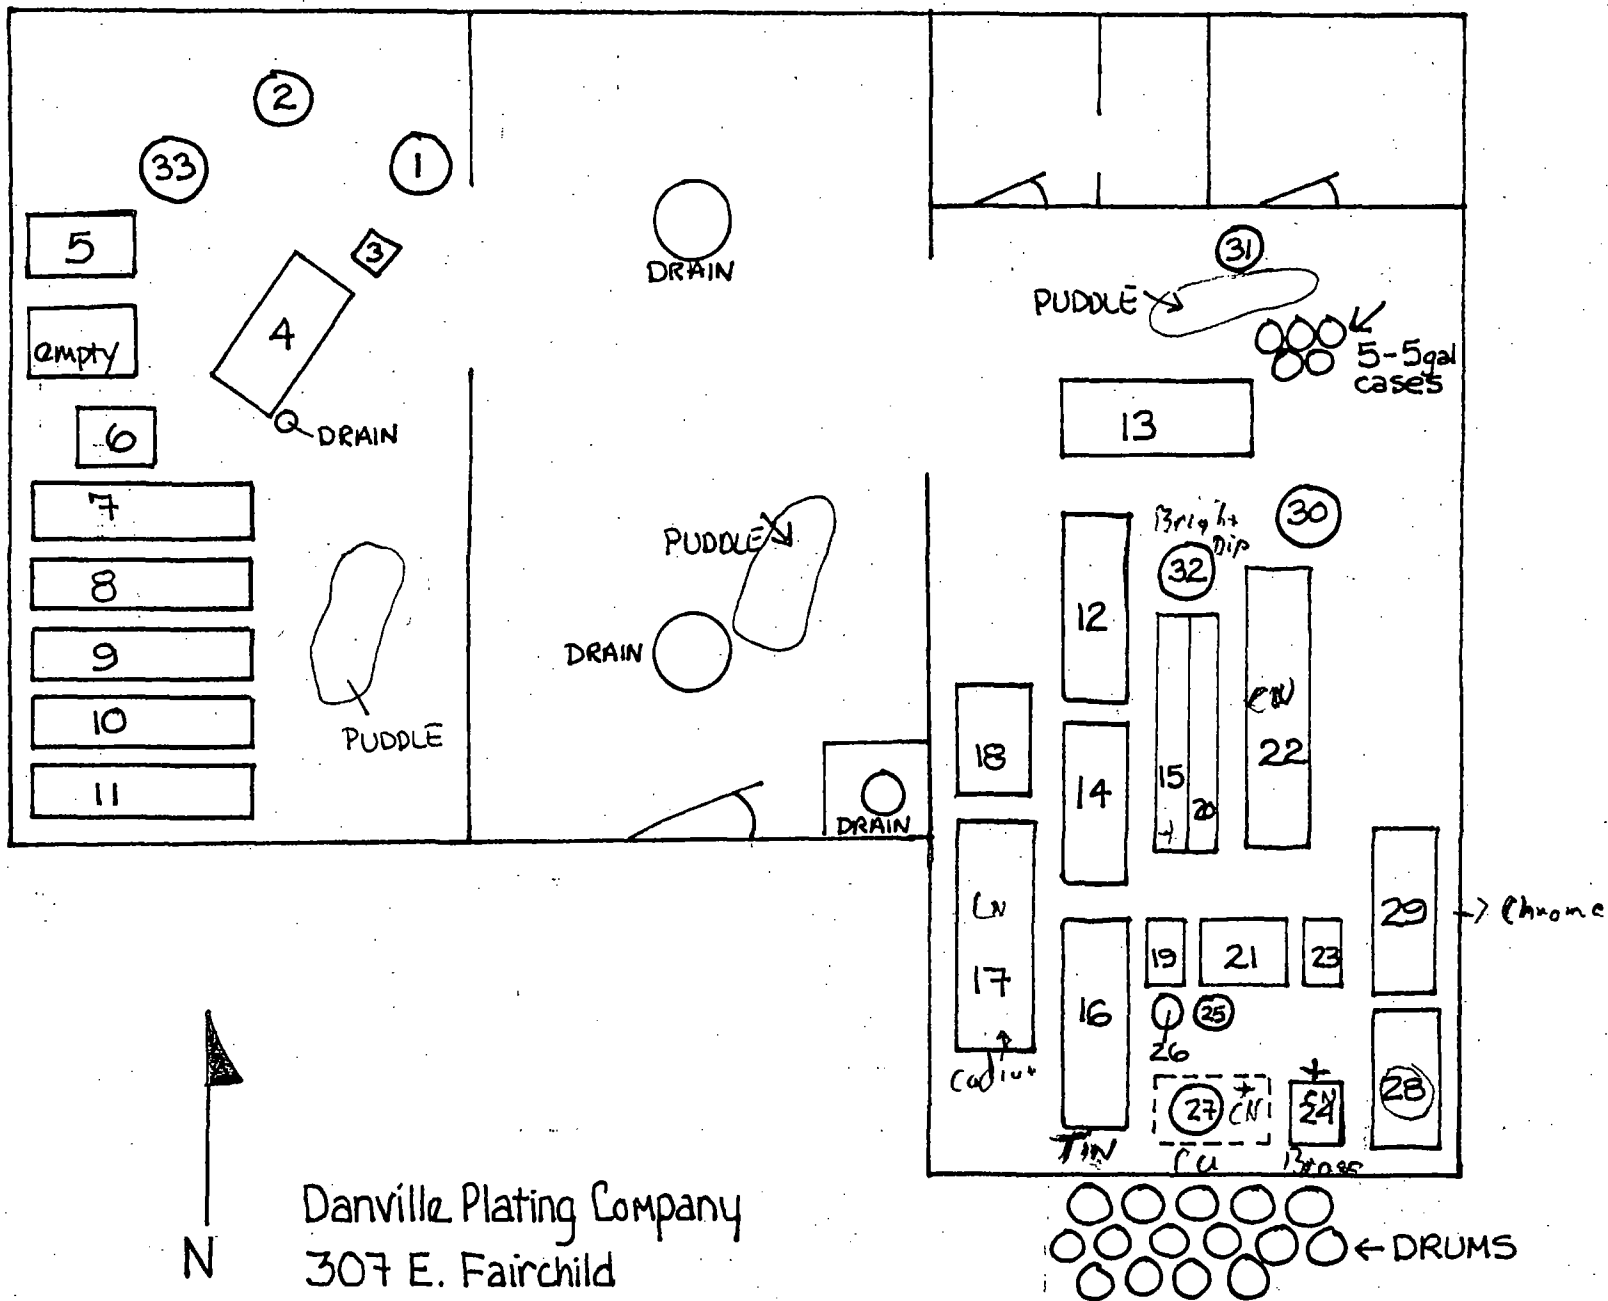
Danville Plating Company  
 307 E. Fairchild  
 11-23-82  
 S. Amendt

The facility consists of a building with three main rooms. (see sketch) Windows are boarded up and the roof is in poor condition, especially in the center room. Rainwater had leaked through in places and filled vats 12, 14, and 16 completely. An old wooden catwalk surrounds the vats 12-32 in the large room. Other debris is present both in the small rooms and around the vats and drums. There are approximately 20 drums in good condition outside of the facility, which are covered with weeds.
